ACOUSTILOG^{INC.}

December 5, 2011

Re: Rooftop HVAC Noise

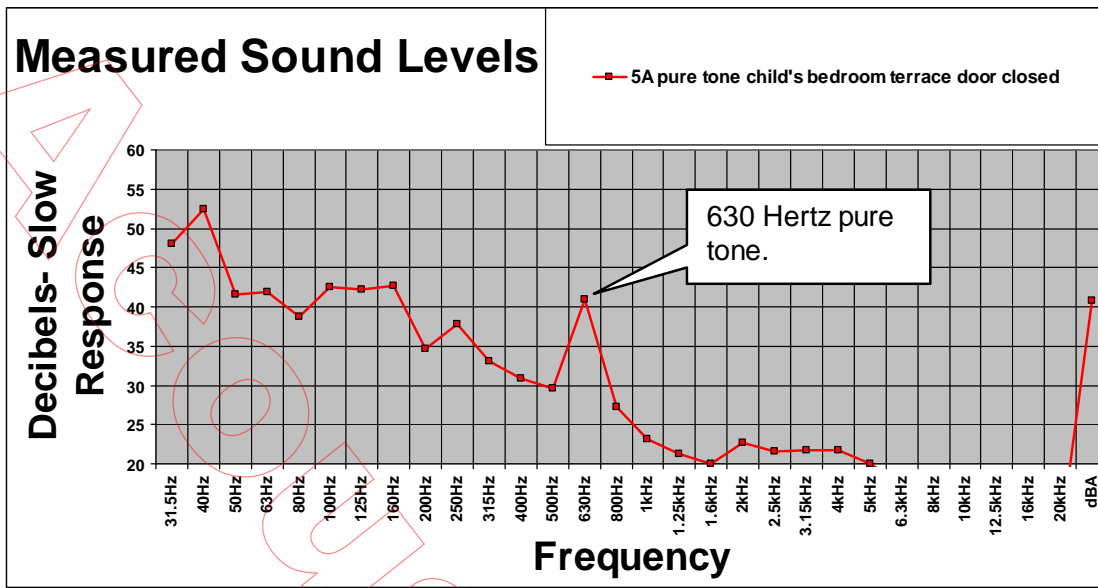
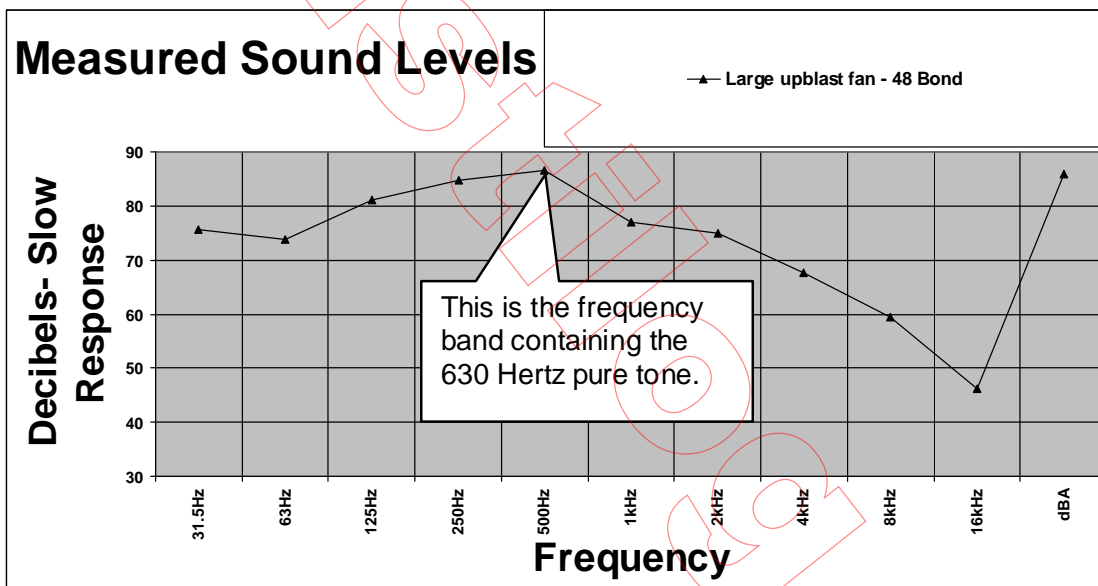
I noticed that when the fans were turning they made no audible noise; I pointed this out to the resident who thought that both fans were off when one was clearly spinning. She then saw this herself. However, the pure tone was heard with the fans running or not. The pure tone consisted of a 630 Hertz continuous "ringing" or "humming" sound, measuring as loud as 41 decibels in the son's bedroom.

Because the sound was from a pure tone source, it varies up and down in level depending on where one measures it. This is due to the existence of "standing waves", a series of high and low loudness locations. The sound bounces back and forth in the room and either adds to or subtracts from the same sound bouncing in another direction. In some places in a room, the combined waves can cancel each other out, while in other locations the sound can be quite strong. Outdoors, pure tones are hard to localize. See the graphs below.

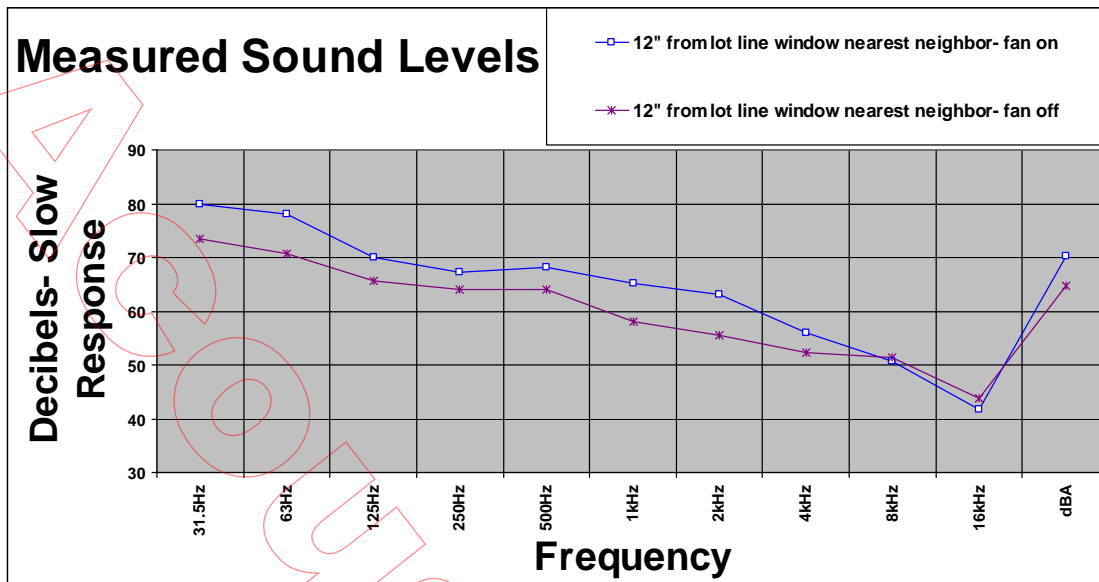
The graph above shows that the fan's noise level is 70 dBA outside the window, and 65 dBA when the fan is off. Accounting for the drop in sound when the window is opened and sound is measured 3 feet inside the opening, I predict that the sound level from the fan is now approximately 60 dBA, still far in excess of the Code limits. However, the actual level depends upon the configuration of the fan enclosure, which has changed in the last several days. Although it is not known whether the noise level I measured today is the actual level measured by the DEP inspector, the soundproofing recommendations which I am providing will greatly lower the sound level.

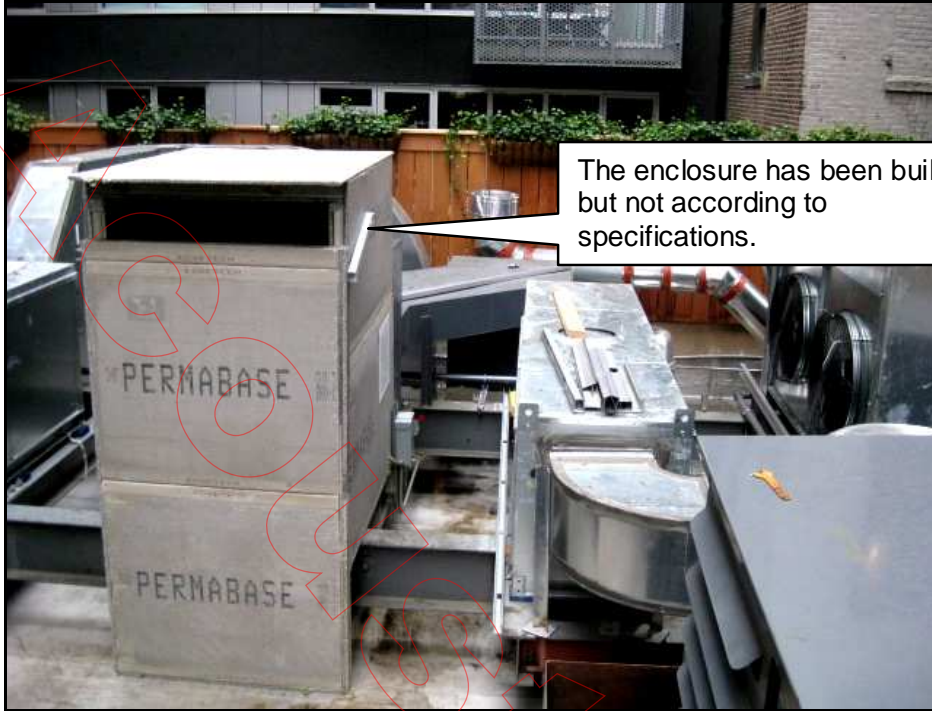
The large exhaust fan now has an enclosure. The enclosure has been built but not according to my specifications. The inside faces are all supposed to have exposed fiberglass insulation. Instead, concrete board was used on the inside as well as the outside, so the fiberglass cannot absorb any of the noise in the enclosure. Take the inner concrete board off.

The enclosure has been built but not according to specifications.

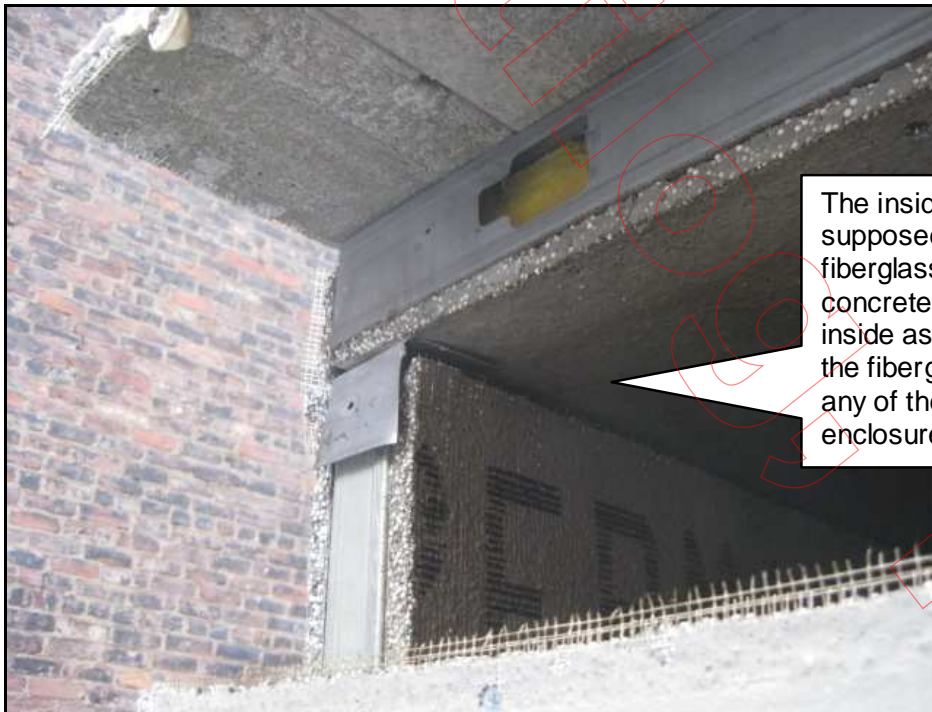
The inside faces are all supposed to have exposed fiberglass insulation. Right now, concrete board is used on the inside as well as the outside, so the fiberglass cannot absorb any of the noise in the enclosure.

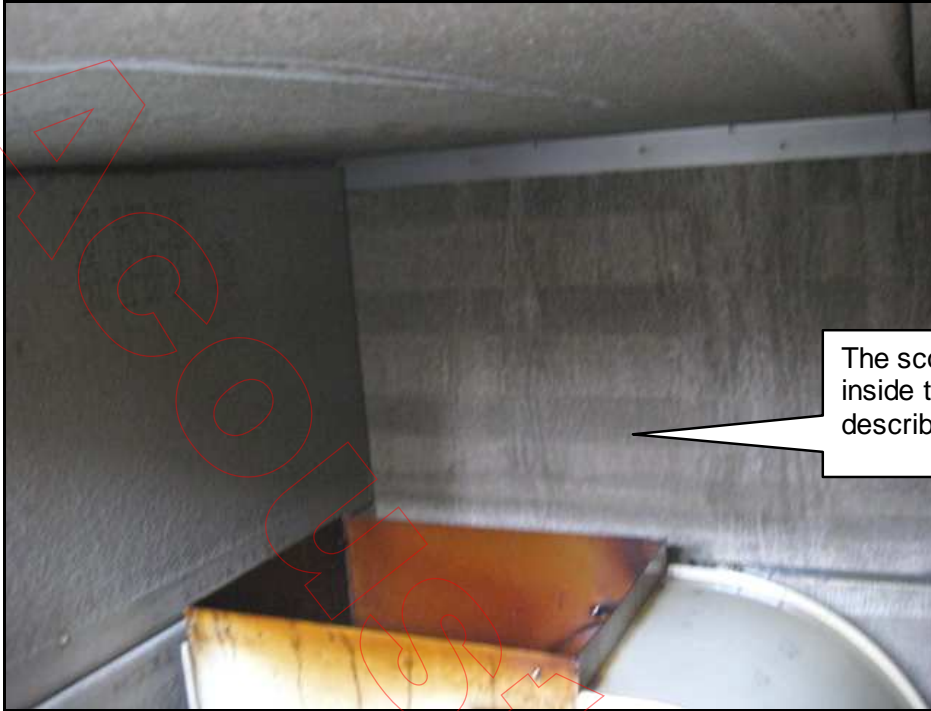
The scoop should be installed inside the enclosure as described in the last report.

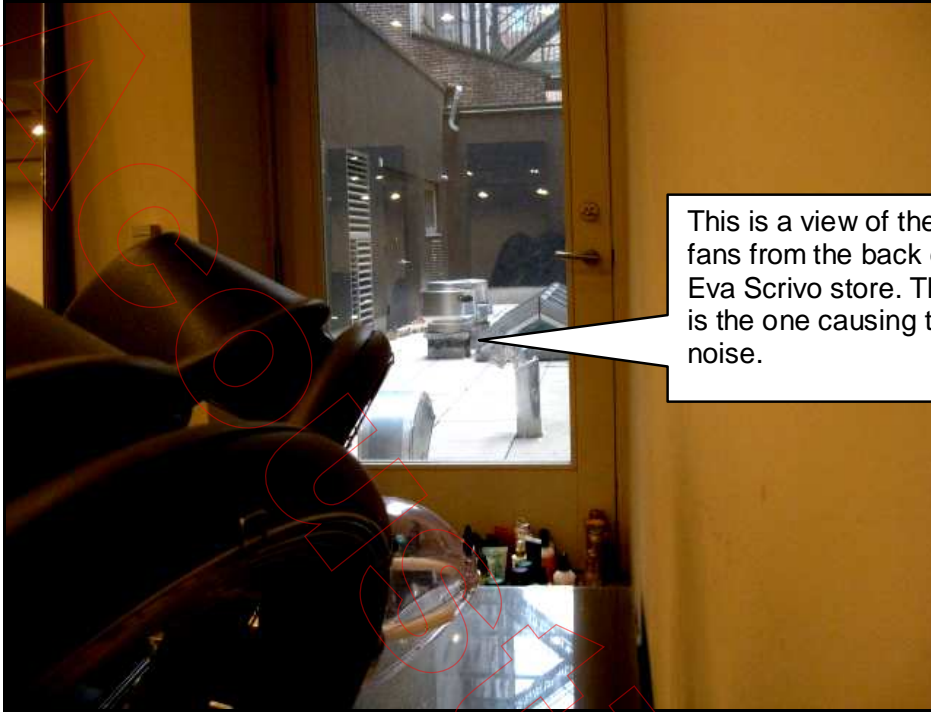
At the end of this report is a photo of the Eva Scrivo store at 50 Bond where I went to investigate the noise of the 48 Bond fans. When I got close to the fans, it was obvious that the large upblast fan is the source of the 630 Hertz tone, measuring 87 decibels in the midrange frequencies 1 foot from the fan. 87 decibels is not approximately “twice” as loud as the 41 decibels in the apartment; it is more than 24 times louder. This proves that the pure tone is definitely coming from 48 Bond’s own fan and not from the

This is a view of the 48 Bond fans from the back door of the Eva Scrivo store. The front fan is the one causing the pure tone noise.

The owners of the 48 Bond fans should fix this problem. My simple suggestion is to have them call their own mechanical contractors to eliminate the noise, which is probably due to a bad bearing in the fan. I can design a solution for them that works if their contractor cannot.

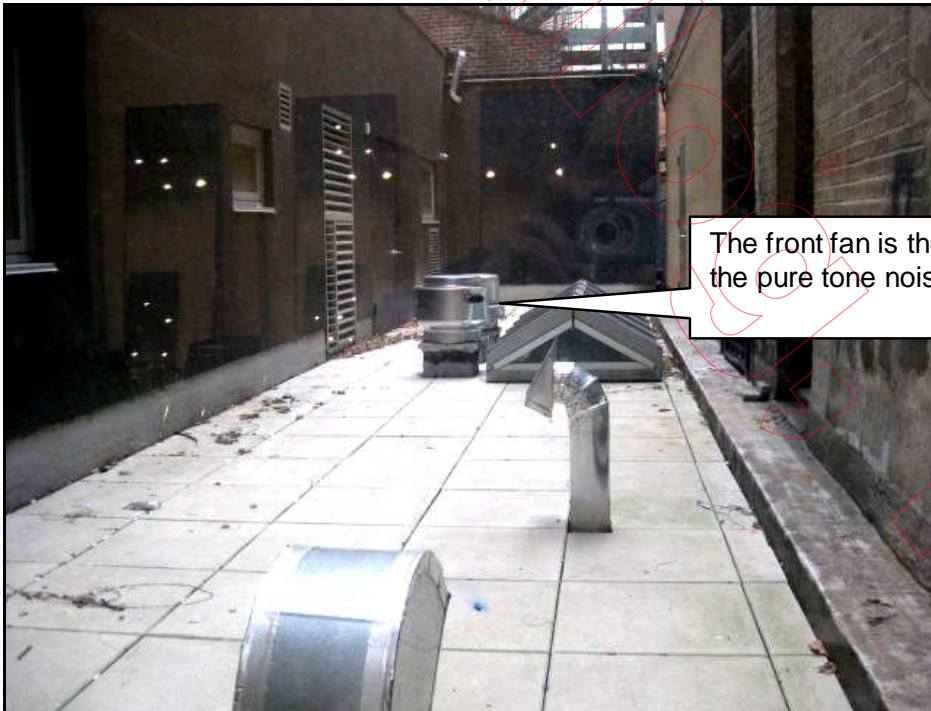
The front fan is the one causing the pure tone noise.

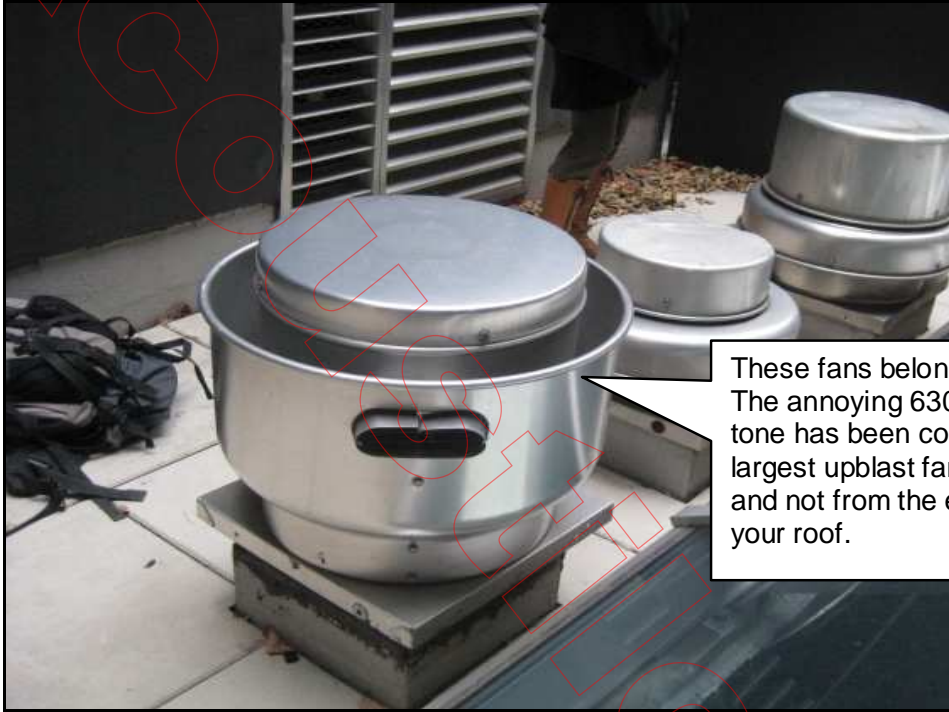
These fans belong to 48 Bond. The annoying 630 Hertz pure tone has been coming from this largest upblast fan on the left, and not from the equipment on your roof.

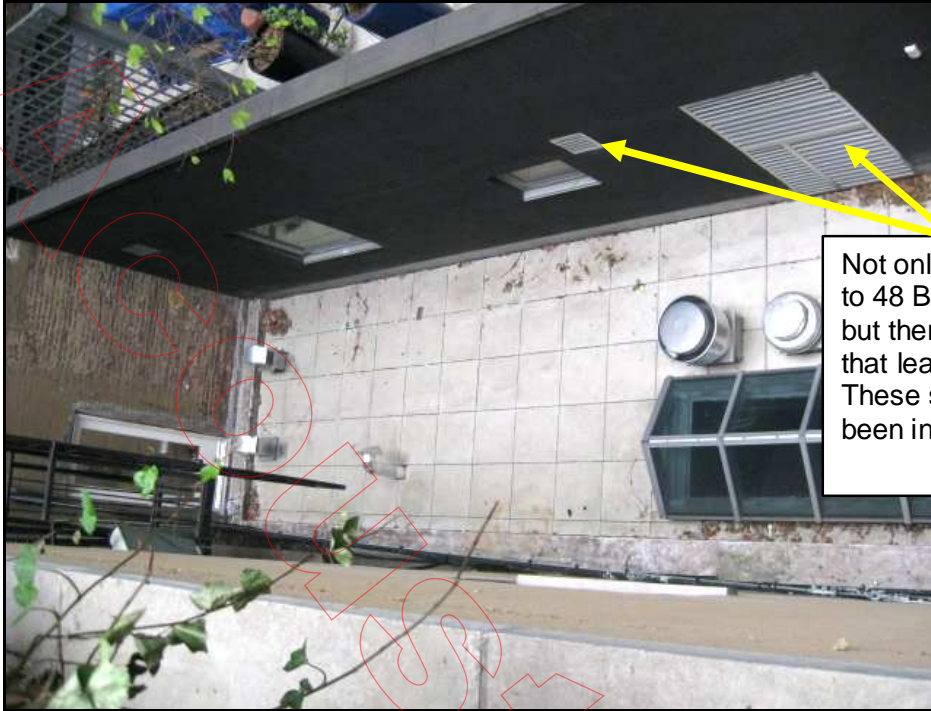
Not only are the fans belonging to 48 Bond a source of noise, but there are other visible grills that lead to other noise sources. These sources have not yet been investigated.

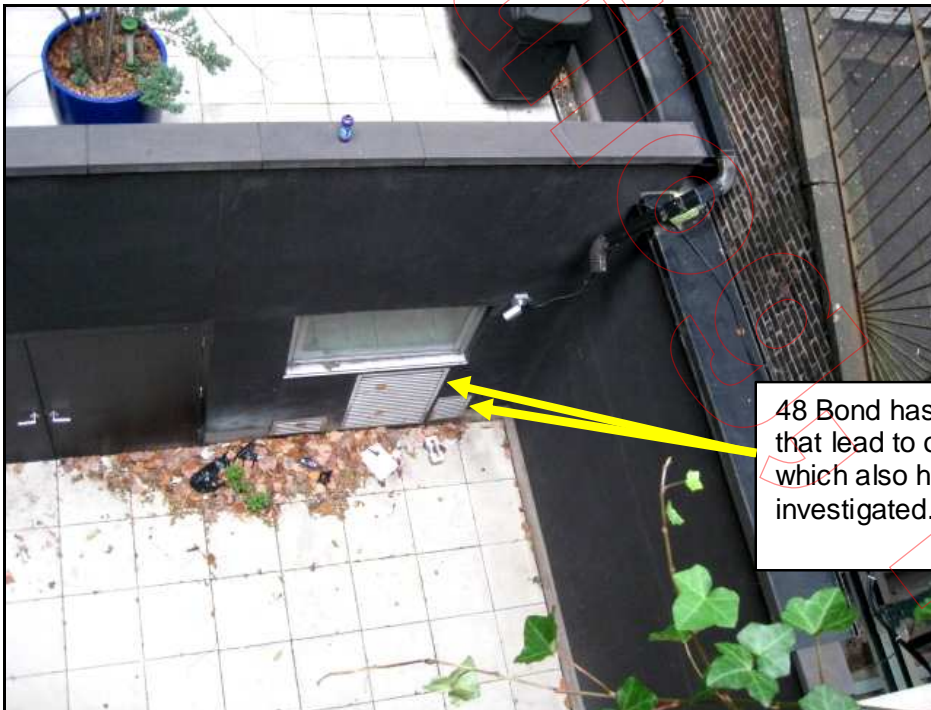
48 Bond has more visible grills that lead to other noise sources, which also have not yet been investigated.

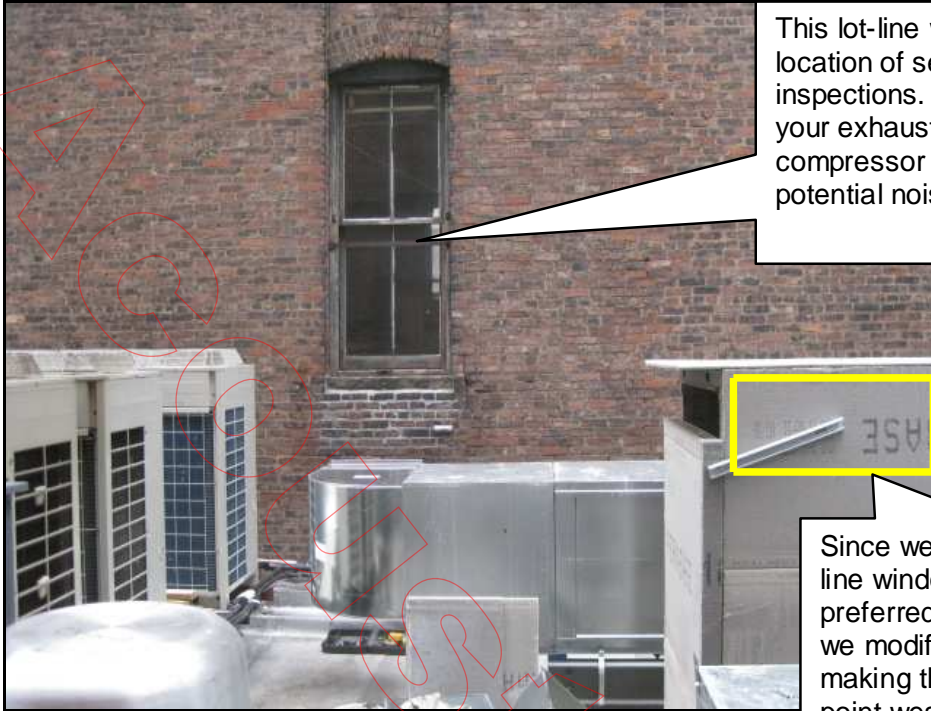
Your contractor, Andre, confirmed my guess that the DEP inspector measured from the lot-line window overlooking your roof deck. As I mentioned before, "lot-line" windows are sometimes referred to as "illegal windows". Also, if they are lot-line windows, they are not built as required and are also not guaranteed to always provide light and air; they can be blocked by neighboring construction in the future.

This lot-line window is the location of several DEP inspections. At this location, your exhaust fan and the silver compressor box can be a potential noise.

Since we now know that the lot line window is the DEP preferred test location, I suggest we modify the box slightly by making the discharge opening point west instead of north.

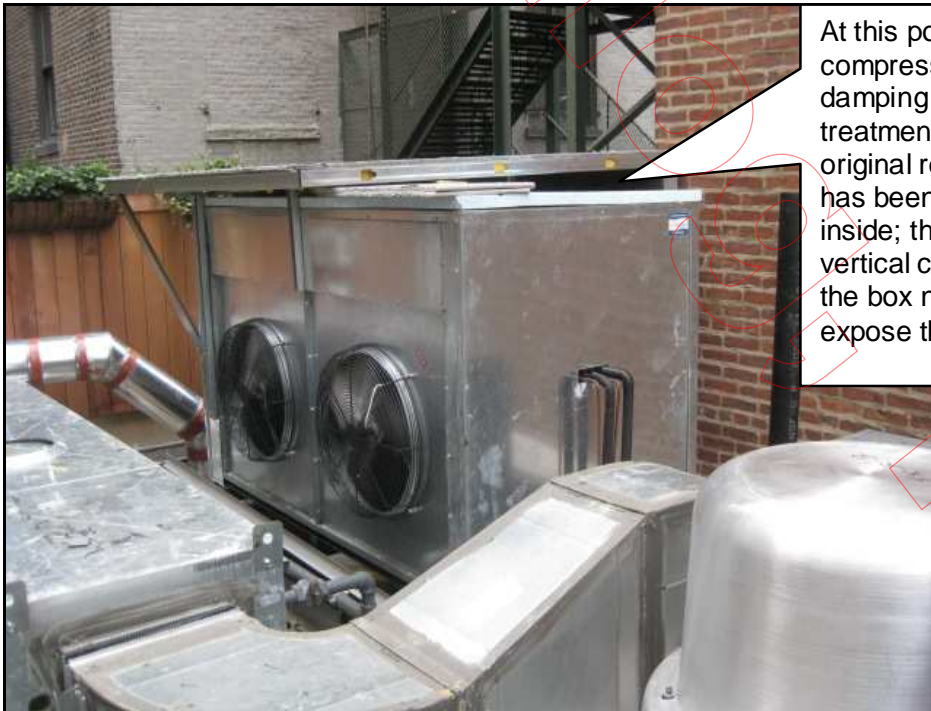
There is a high frequency noise coming from the compressors inside the silver cabinet but not from the two fans themselves.

At this point, the silver compressor box needs the inner damping and fiberglass treatment that I described in my original report. Also, a cover has been put on with fiberglass inside; this can remain but the vertical concrete board facing the box needs to be removed to expose the yellow fiberglass.
